**Flood Control Project Maintenance  
Levee Inspections**

**Spring 2016 Levee Inspection Results**

**Yolo County Service Area 6**

Waterway				Bank	Unit Miles
Unit No. 01 Right Bank of Sacramento River at Knights Landing				Right	5.87
	Spring (March - May)	Summer (June - August)	(September - November) Fall	Winter (December - February)	
Unit Maintenance Rating (Fall Only)					
Date of Inspection	4/12/2016 - 4/12/2016				
DWR Inspector	Jai Lor				
Accompanied By

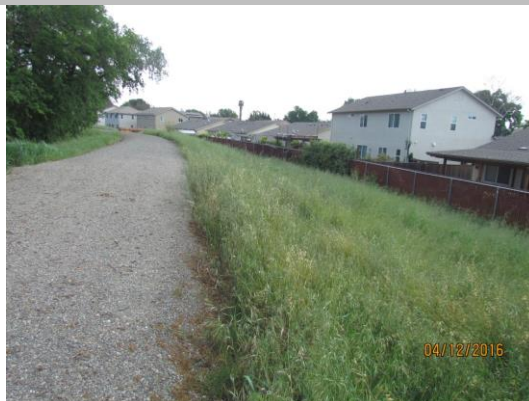
Photo 1 of 1 : SP\_2016\_NA0022\_350\_67\_20160413\_00141.jpg

LM Start	0.00	Rating **	U	Issue No.	67
LM End	0.20	Issue Type +	Ma	Location *	LS
Category	Earthen Levee			GPS Latitude/Longitude	
				Start	End
Item	Vegetation			38.799173 °	38.801334 °
				-121.724448 °	-121.722108 °
DWR ID	DWR_NA0022_01_f_2015_67				
Comment Code					
V1 : Control annual grass and weeds on the levee slopes and easements.					
Inspector Comment					
Clear vegetation on landside slope.

View of the vegetation on the landward side of the levee looking downstream. Spring 2016.

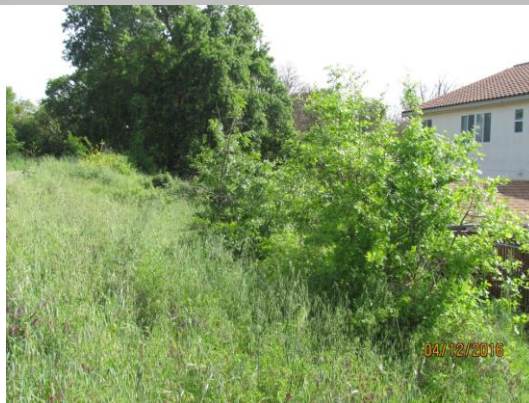
Photo 1 of 1 : SP\_2016\_NA0022\_350\_65\_20160413\_00143.jpg

LM Start	0.07	Rating **	M	Issue No.	65
LM End	0.08	Issue Type +	Ma	Location *	LS
Category	Earthen Levee			GPS Latitude/Longitude	
				Start	End
Item	Vegetation			38.800005 °	38.800143 °
				-121.723875 °	-121.723793 °
DWR ID	DWR_NA0022_01_s _ 2016_65				
Comment Code					
V2 : Remove the wild growth other than native grasses from the levee slopes.					
Inspector Comment					
Remove oak trees less than 4" in diameter at chest height on both sides of slope and trim trees.

View of the small oak trees on the landward side of the levee looking downstream. Spring 2016.

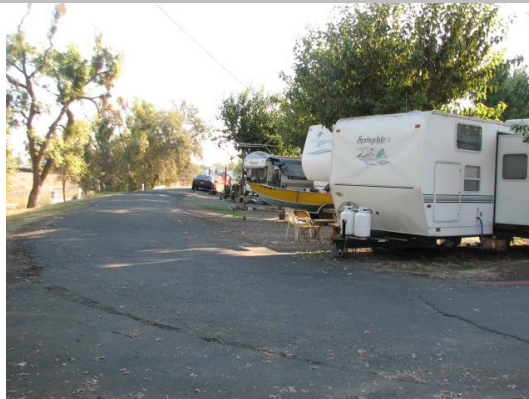
Photo 1 of 2 : SP\_2016\_NA0022\_350\_28\_20160304\_00026.jpg

LM Start	<b>0.22</b>	Rating **	M	Issue No.	<b>28 (cont)</b>
LM End	<b>0.25</b>	Issue Type +	En	Location *	LS

The RV park is encroached into the levee crown. Fall 2013

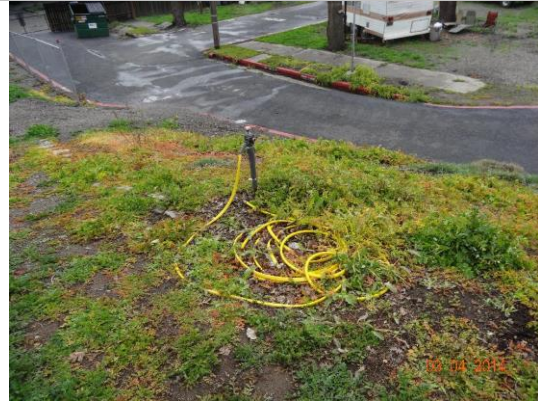
Photo 1 of 2 : UCIP\_SP\_2016\_45403\_60805.jpg

LM Start	0.26	Rating **	M	Issue No.	421
LM End	0.26	Issue Type +	En	Location *	LS
Category	Supplemental			GPS Latitude/Longitude	
				Start	End
Item	DWR UCIP Field Study			38.801597 °	38.801597 °
				-121.721226 °	-121.721226 °
DWR ID					
Comment Code					
Inspector Comment					
FS_ID:45403 DS_ID:19513 EP_NO: 9424 Repair Type: Non-Urgent Crossing Status: Indicator Found UCIP Comments: Unable to determine alignment of crossing--it's either through levee or along landward side. It appears that the waterline goes along landward side. Need to contact owner to obtain additional information about crossing. 2 inch metal pipe sticking out at the waterward berm edge. FIELD_STRUCT_DESC: Water pipe through the levee. Faucets in the landward slope. (ABO Permit No. 9424-1974). FS Date: 3/4/2014

Spigot located on landward side.

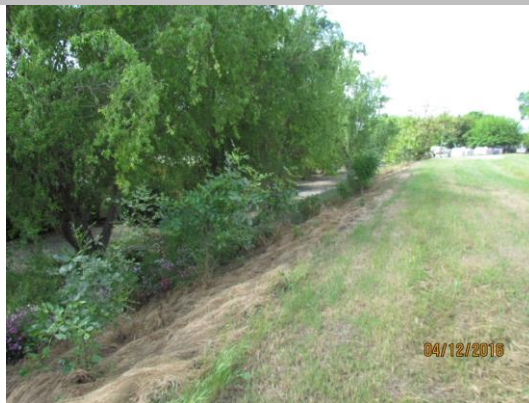
Photo 1 of 2 : SP\_2016\_NA0022\_350\_27\_20160413\_00148.jpg

LM Start	0.30	Rating **	M	Issue No.	27
LM End	0.32	Issue Type +	En	Location *	LS
Category	Earthen Levee			GPS Latitude/Longitude	
				Start	End
Item	Vegetation			38.801720 °	38.801840 °
				-121.720447 °	-121.720030 °
DWR ID	DWR_NA0022_01_s _ 2012_27				
Comment Code					
V6 : Landscaping					
Inspector Comment					
I have talked to the owner about a permit and he continues to landscape the landside slope with no permit. Owner has added fence across levee. I gave her an application and did a field investigation report.

View of the landscaping on the landward slope of the levee looking upstream. Spring 2016.

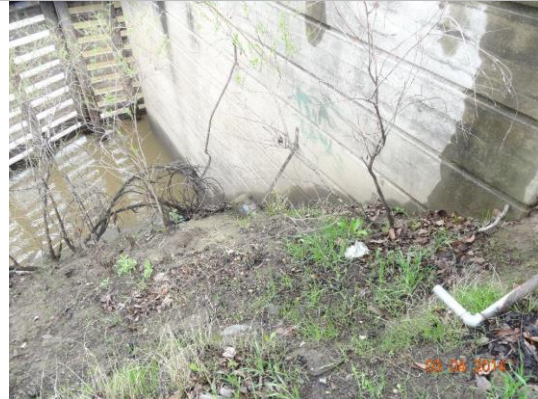
Photo 1 of 2 : UCIP\_SP\_2016\_31906\_58238.jpg

Comment Code						
Inspector Comment						
FS_ID:31906 DS_ID:19534 EP_NO: 17016 Repair Type: Non-Urgent Crossing Status: Indicator Found UCIP Comments: Unable to confirm crossing alignment--steel pipe visible on waterward side however, unable to confirm if crossing is the same one found during field confirmation. Need to contact owner to verify alignment and status of crossing. Slope was too steep to verify and obtain additional information about pipe. FIELD_STRUCT_DESC: Three 2-inch diameter and three 1.5-inch diameter fiber optic conduits through the levee, encased in a single HDPE conduit, 30-feet below the levee crown. Concrete caps on both ends of the casing, on the landward and waterward sides. Voids in the HDPE conduit grouted. (Permit No. 17016-2000). FS Date: 3/4/2014

Steel pipe located on waterward side--pipe disconnected.

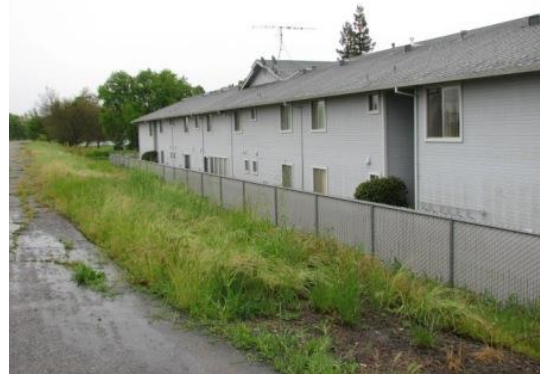
Photo 1 of 1 : SP\_2016\_NA0022\_350\_26\_20160304\_00024.jpg

LM Start	0.35	Rating **	A/W	Issue No.	26
LM End	0.39	Issue Type +	En	Location *	LS
Category	Earthen Levee			GPS Latitude/Longitude	
				Start	End
Item	Encroachments			38.801886 °	38.802020 °
				-121.719588 °	-121.718889 °
DWR ID	DWR_NA0022_01_s _ 2012_26				
Comment Code					
BU : Building					
Inspector Comment					
Apartments with chainlink fence with lathe woven into it.

The apartments and fence along the toe of the levee. Fall 2013

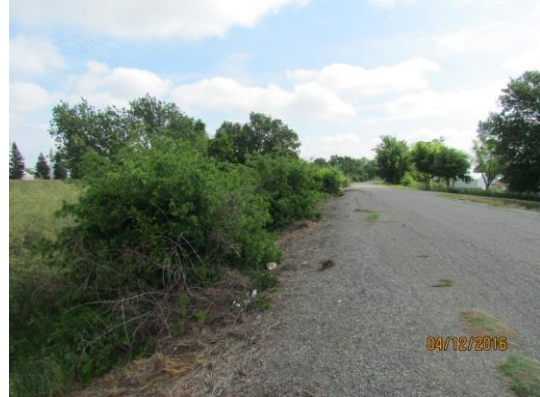
Photo 1 of 1 : SP\_2016\_NA0022\_350\_102\_20160413\_00149.jpg

LM Start	0.35	Rating **	M	Issue No.	102
LM End	0.48	Issue Type +	Ma	Location *	WS
Category	Earthen Levee			GPS Latitude/Longitude	
				Start	End
Item	Vegetation			38.801887 °	38.802225 °
				-121.719587 °	-121.717186 °
DWR ID	DWR_NA0022_01_s _ 2016_102				
Comment Code					
V2 : Remove the wild growth other than native grasses from the levee slopes.					
Inspector Comment					
Remove oak tree that is less than 4" at breast height.

View of the trees on the waterward side of the levee looking downstream. Spring 2016.

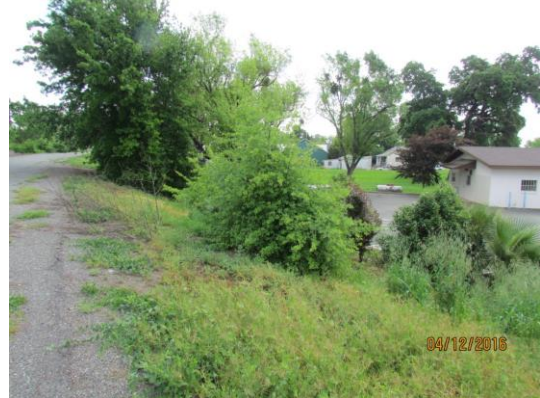
Photo 1 of 1 : SP\_2016\_NA0022\_350\_104\_20160413\_00150.jpg

LM Start	0.42	Rating **	M	Issue No.	104
LM End	0.43	Issue Type +	En	Location *	LS
Category	Earthen Levee			GPS Latitude/Longitude	
				Start	End
Item	Vegetation			38.802106 °	38.802126 °
				-121.718269 °	-121.718133 °
DWR ID	DWR_NA0022_01_s_2016_104				
Comment Code					
V6 : Landscaping					
Inspector Comment					
Remove trees that are less than 4'.

View of the tree on the landward side of the levee looking downstream. Spring 2016.

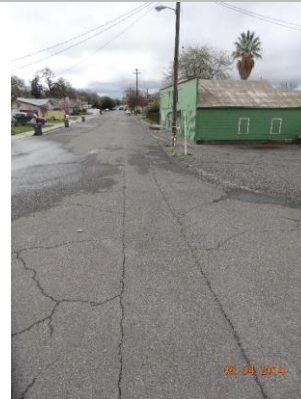
Photo 1 of 2 : UCIP\_SP\_2016\_31627\_57881.jpg

LM Start	0.51	Rating **	M	Issue No.	412
LM End	0.51	Issue Type +	En	Location *	WS
Category	Supplemental			GPS Latitude/Longitude	
				Start	End
Item	DWR UCIP Field Study			38.802062 °	38.802062 °
				-121.716740 °	-121.716740 °
DWR ID					
Comment Code					
Inspector Comment					
FS_ID:31627 DS_ID:19544 EP_NO: N/A Repair Type: Non-Urgent Crossing Status: Indicator Found UCIP Comments: Unable to confirm if signs of crossing are for the same crossing listed here. Need to contact owner and determine additional information about crossing. Also found is service box for water line--need permit and alignment confirmation. FIELD_STRUCT_DESC: 10-inch steel pipe through the levee. (USACE-1953). This entry matches the Drainage or Irrigation Structure referenced in O&M manual (Station 285+27). FS Date: 3/4/2014

View of landward side. Alignment is visible on paved road.

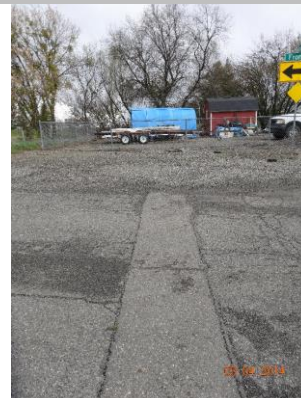
Photo 2 of 2 : UCIP\_SP\_2016\_31627\_57880.jpg

View of waterward side. Alignment is visible on paved road.

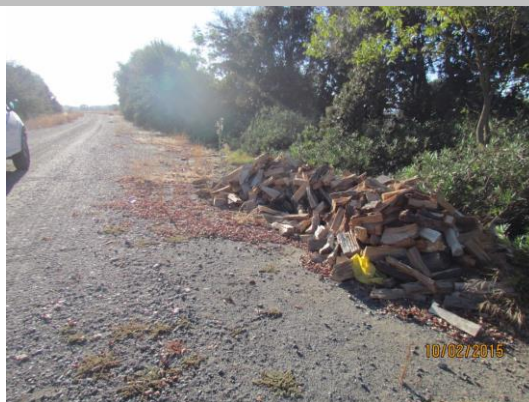
Photo 1 of 1 : SP\_2016\_NA0022\_350\_70\_20160304\_00049.jpg

LM Start	0.65	Rating **	M	Issue No.	70
LM End	0.65	Issue Type +	En	Location *	LS
Category	Earthen Levee			GPS Latitude/Longitude	
				Start	End
Item	Encroachments			38.801372 °	38.801372 °
				-121.714247 °	-121.714247 °
DWR ID	DWR_NA0022_01_f_2015_70				
Comment Code					
FW : Firewood					
Inspector Comment

View of the firewood on the landward side of the levee looking downstream. Fall 2015.

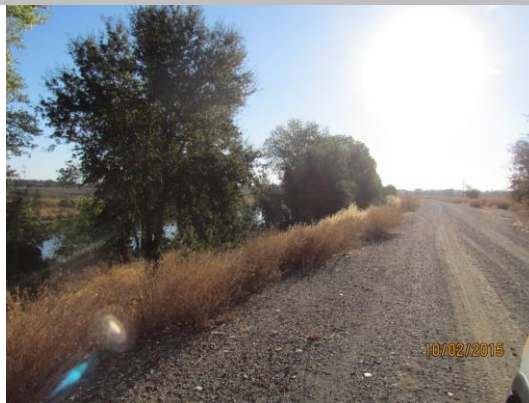
Photo 1 of 1 : SP\_2016\_NA0022\_350\_71\_20160304\_00050.jpg

LM Start	0.68	Rating **	M	Issue No.	71
LM End	0.95	Issue Type +	Ma	Location *	WS
Category	Earthen Levee			GPS Latitude/Longitude	
				Start	End
Item	Vegetation			38.801181 °	38.800237 °
				-121.713724 °	-121.708977 °
DWR ID	DWR_NA0022_01_f_2015_71				
Comment Code					
V1 : Control annual grass and weeds on the levee slopes and easements.					
Inspector Comment

View of the vegetation on the waterward side of the levee looking downstream. Fall 2015.

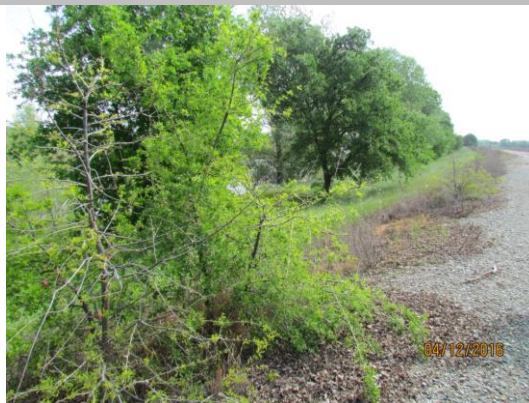
Photo 1 of 1 : SP\_2016\_NA0022\_350\_106\_20160413\_00151.jpg

LM Start	0.70	Rating **	M	Issue No.	106
LM End	0.70	Issue Type +	Ma	Location *	WS
Category	Earthen Levee			GPS Latitude/Longitude	
				Start	End
Item	Vegetation			38.801059 °	38.801059 °
				-121.713373 °	-121.713373 °
DWR ID	DWR_NA0022_01_s_2016_106				
Comment Code					
V2 : Remove the wild growth other than native grasses from the levee slopes.					
Inspector Comment					
Remove oak tree less than 4" at chest height that is within 20' of waterside shoulder.

View of the small tree on the waterward side of the levee looking downstream. Spring 2016.

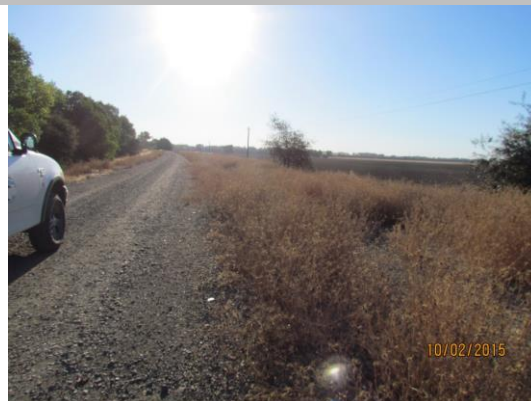
Photo 1 of 1 : SP\_2016\_NA0022\_350\_72\_20160304\_00051.jpg

LM Start	0.73	Rating **	M	Issue No.	72
LM End	0.95	Issue Type +	Ma	Location *	LS
Category	Earthen Levee			GPS Latitude/Longitude	
				Start	End
Item	Vegetation			38.800949 °	38.800230 °
				-121.712939 °	-121.709004 °
DWR ID	DWR_NA0022_01_f_2015_72				
Comment Code					
V1 : Control annual grass and weeds on the levee slopes and easements.					
Inspector Comment

View of the vegetation on the landward side of the levee looking downstream. Fall 2015.

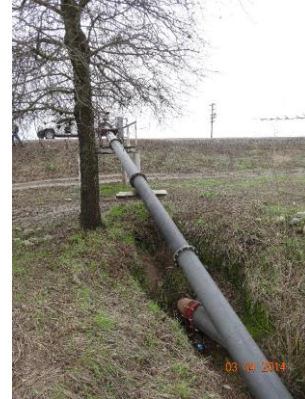
Photo 2 of 2 : UCIP\_SP\_2016\_31969\_58409.jpg

LM Start	0.93	Rating **	M	Issue No.	410 (cont)
LM End	0.93	Issue Type +	En	Location *	LS
Category	Supplemental			GPS Latitude/Longitude	
				Start	End
Item	DWR UCIP Field Study			38.800200 °	38.800200 °
				-121.709258 °	-121.709258 °
DWR ID					
Comment Code					
Inspector Comment					
FS_ID:31969 DS_ID:19540 EP_NO: N/A Repair Type: Non-Urgent Crossing Status: Found UCIP Comments: Pipe section on waterward side appears to have been removed and reinstalled--Need to contact owner to obtain additional information regarding work completed. FIELD_STRUCT_DESC: 14-inch steel drain pipe through the levee. Pump and valve on waterside bank. (USACE-1953). This entry matches the Drainage or Irrigation Structure referenced in O&M manual (Station 266+72.2). Pipe and pump completely replaced under Permit No. 3798 (1962). FS Date: 3/4/2014

Pipe located on waterward side.

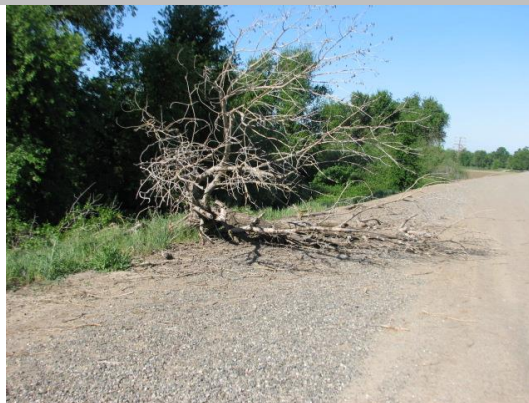
Photo 1 of 1 : SP\_2016\_NA0022\_350\_17\_20160304\_00016.jpg

LM Start	1.01	Rating **	M	Issue No.	17
LM End	1.01	Issue Type +	Ma	Location *	LS
Category	Earthen Levee			GPS Latitude/Longitude	
				Start	End
Item	Encroachments			38.800246 °	38.800246 °
				-121.707858 °	-121.707858 °
DWR ID	DWR_NA0022_01_s _ 2014_17				
Comment Code					
TR : Tree or limb					
Inspector Comment					
Trees blocking visibility and a dead tree on the levee slope.

A tree has fallen on the crown and blocks visibility. Spring 2014

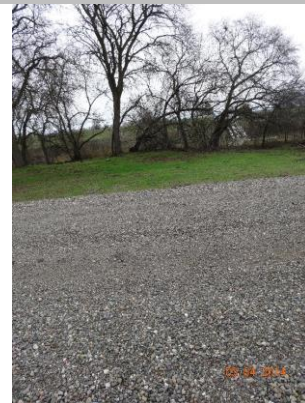
Photo 1 of 2 : UCIP\_SP\_2016\_38190\_69563.jpg

LM Start	1.75	Rating **	M	Issue No.	420
LM End	1.75	Issue Type +	En	Location *	WS
Category	Supplemental			GPS Latitude/Longitude	
				Start	End
Item	DWR UCIP Field Study			38.797928 °	38.797928 °
				-121.697992 °	-121.697992 °
DWR ID					
Comment Code					
Inspector Comment					
FS_ID:38190					
DS_ID:19539					
EP_NO: N/A					
Repair Type: Non-Urgent					
Crossing Status: Indicator Found					
UCIP Comments: Need to contact owner to determine status of crossing.					
FIELD_STRUCT_DESC: Abandoned 12-inch (not 18-inch as mentioned in USACE O&M manual) CM drain pipe through the levee. Gate valve in pumphouse on waterward side. (USACE-1953). This entry matches the Drainage or Irrigation Structure referenced in O&M manual (Station 224+3.5). Drain pipe was abandoned prior to 1968.					
FS Date: 3/4/2014

View of waterward side.

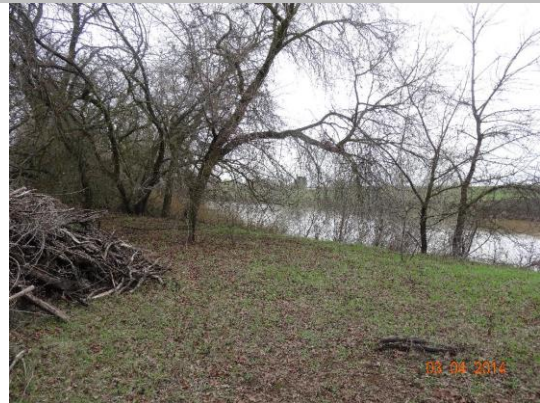
Photo 2 of 2 : UCIP\_SP\_2016\_38190\_69565.jpg

LM Start	1.75	Rating **	M	Issue No.	420 (cont)
LM End	1.75	Issue Type +	En	Location *	WS
Category	Supplemental			GPS Latitude/Longitude	
				Start	End
Item	DWR UCIP Field Study			38.797928 °	38.797928 °
				-121.697992 °	-121.697992 °
DWR ID					
Comment Code					
Inspector Comment					
FS_ID:38190 DS_ID:19539 EP_NO: N/A Repair Type: Non-Urgent Crossing Status: Indicator Found UCIP Comments: Need to contact owner to determine status of crossing. FIELD_STRUCT_DESC: Abandoned 12-inch (not 18-inch as mentioned in USACE O&M manual) CM drain pipe through the levee. Gate valve in pumphouse on waterward side. (USACE-1953). This entry matches the Drainage or Irrigation Structure referenced in O&M manual (Station 224+3.5). Drain pipe was abandoned prior to 1968. FS Date: 3/4/2014

View of waterward side.

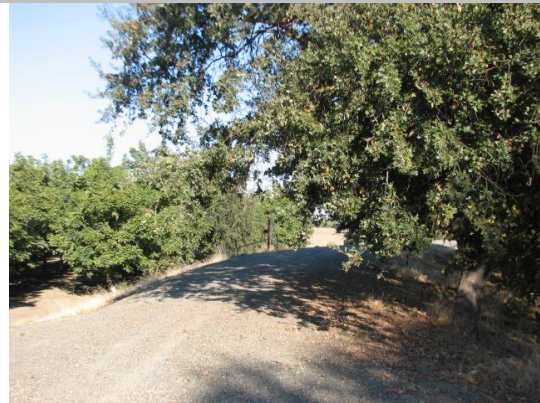
Photo 1 of 1 : SP\_2016\_NA0022\_350\_9\_20160304\_00010.jpg

LM Start	1.80	Rating **	M	Issue No.	9
LM End	1.80	Issue Type +	Ma	Location *	CR
Category	Earthen Levee			GPS Latitude/Longitude	
				Start	End
Item	Trim / Thin Trees			38.797228 °	38.797228 °
				-121.697577 °	-121.697577 °
DWR ID	DWR_NA0022_01_f_2013_9				
Comment Code					
T4 : Trim trees over roadway to at least 12 feet above ground level.					
Inspector Comment

Trees need to be trimmed up to 12 feet above the crown. Fall 2013

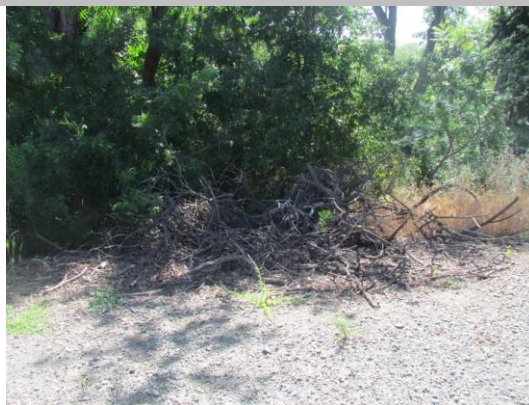
Photo 1 of 1 : SP\_2016\_NA0022\_350\_44\_20160304\_00039.jpg

LM Start	1.95	Rating **	M	Issue No.	44
LM End	1.95	Issue Type +	En	Location *	WS
Category	Earthen Levee			GPS Latitude/Longitude	
				Start	End
Item	Encroachments			38.795536 °	38.795536 °
				-121.695977 °	-121.695977 °
DWR ID	DWR_NA0022_01_s_2013_44				
Comment Code					
PR : Prunings					
Inspector Comment

View of the prunings on the waterward side of the levee. Spring 2015.

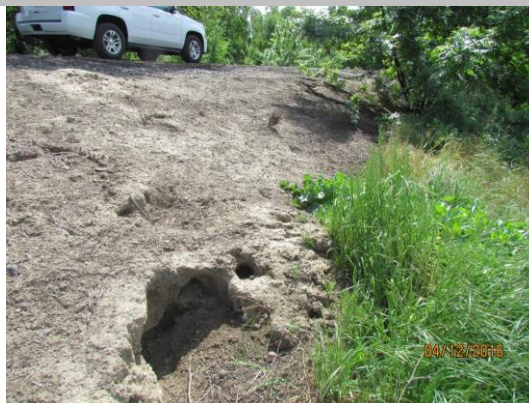
Photo 1 of 1 : SP\_2016\_NA0022\_350\_119\_20160413\_00155.jpg

LM Start	1.96	Rating **	U	Issue No.	119	
LM End	1.96	Issue Type +	Ma	Location *	LS	
Category	Earthen Levee			GPS Latitude/Longitude		
				Start		End
Item	Animal Control			38.795418 °		38.795418 °
				-121.695964 °		-121.695964 °
DWR ID	DWR_NA0022_01_s_2016_119					
Comment Code						
A3 : No rodents visible, but rodent burrows visible; need to backfill and compact or grout burrows.						
Inspector Comment

View of the rodent hole on the landward side of the levee. Spring 2016.

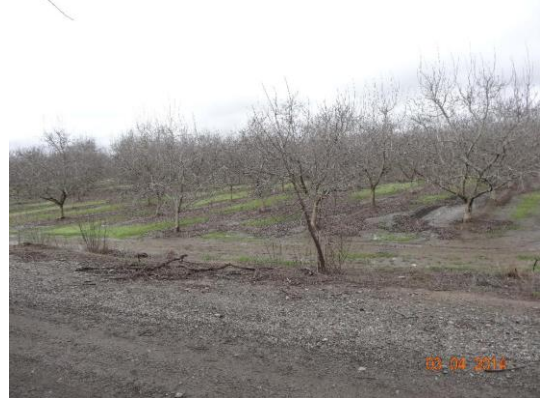
Photo 1 of 2 : UCIP\_SP\_2016\_40536\_58265.jpg

LM Start	1.97	Rating **	M	Issue No.	418
LM End	1.97	Issue Type +	En	Location *	LS
Category	Supplemental			GPS Latitude/Longitude	
				Start	End
Item	DWR UCIP Field Study			38.795248 °	38.795248 °
				-121.695958 °	-121.695958 °
DWR ID					
Comment Code					
Inspector Comment					
FS_ID:40536 DS_ID:19524 EP_NO: 9413 Repair Type: Non-Urgent Crossing Status: Found UCIP Comments: Alignment through levee unknown--no signs of crossing through landward side. Need to contact owner to determine status of crossing. This crossing appears to have been updated since 1970s. FIELD_STRUCT_DESC: 24-inch pipe through the levee, 15.5-feet below the crown. Gate valve on the landward end. Ramp on waterward slope. (ABO Permit No. 9413-1974). FS Date: 3/4/2014

View of landward side.

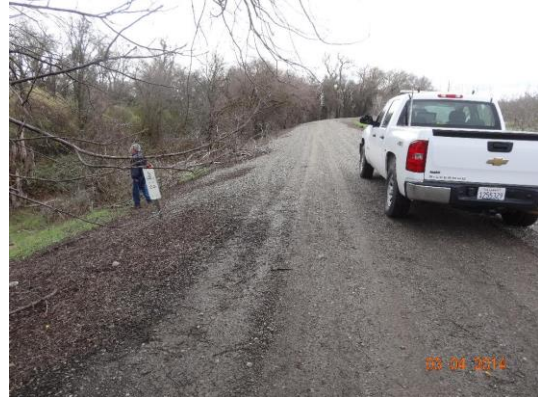
Photo 2 of 2 : UCIP\_SP\_2016\_40536\_58264.jpg

LM Start	1.97	Rating **	M	Issue No.	418 (cont)	
LM End	1.97	Issue Type +	En	Location *	LS	
Category	Supplemental			GPS Latitude/Longitude		
				Start	End	
Item	DWR UCIP Field Study			38.795248 °	38.795248 °	
				-121.695958 °	-121.695958 °	
DWR ID						
Comment Code						
Inspector Comment						
FS_ID:40536 DS_ID:19524 EP_NO: 9413 Repair Type: Non-Urgent Crossing Status: Found UCIP Comments: Alignment through levee unknown--no signs of crossing through landward side. Need to contact owner to determine status of crossing. This crossing appears to have been updated since 1970s. FIELD_STRUCT_DESC: 24-inch pipe through the levee, 15.5-feet below the crown. Gate valve on the landward end. Ramp on waterward slope. (ABO Permit No. 9413-1974). FS Date: 3/4/2014

View of levee crown at crossing.

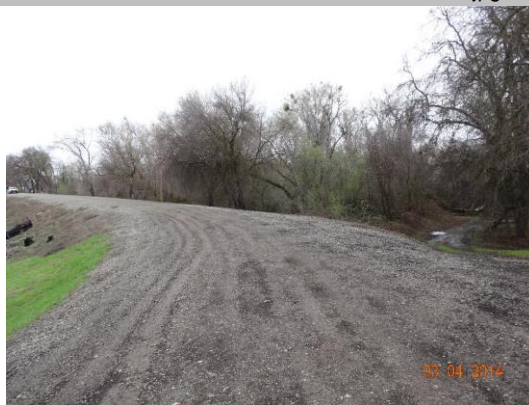
Photo 2 of 2 : UCIP\_SP\_2016\_31632\_57903.jpg

LM Start	2.04	Rating **	M	Issue No.	413
LM End	2.04	Issue Type +	En	Location *	WS
Category	Supplemental			GPS Latitude/Longitude	
				Start	End
Item	DWR UCIP Field Study			38.794288 °	38.794288 °
				-121.695678 °	-121.695678 °
DWR ID					
Comment Code					
Inspector Comment					
FS_ID:31632					
DS_ID:19523					
EP_NO: 9413					
Repair Type: Non-Urgent					
Crossing Status: Indicator Found					
UCIP Comments: Erosion at outlet. Unable to determine if crossing is still in use. Will need to contact owner to determine status of crossing.					
FIELD_STRUCT_DESC: 30-inch CM gravity drainpipe through the levee, 13.5-feet below the crown. Slide gate on both ends in 48-inch CM pipe riser. Drainpipe retained under ABO Permit No. 9413 (1974).					
Pump on waterward side, installed under Permit No. 12804 (1980).					
FS Date: 3/4/2014

Overview of levee crown at crossing.

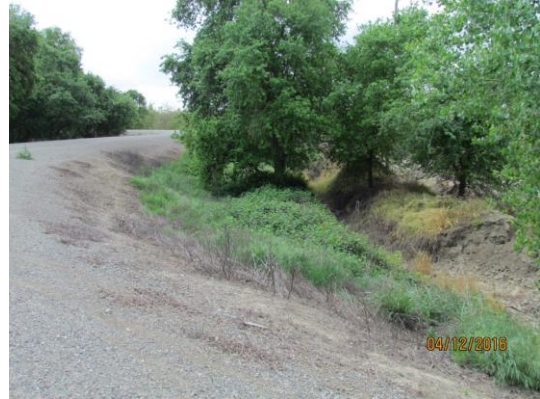
Photo 1 of 1 : SP\_2016\_NA0022\_350\_7\_20160413\_00156.jpg

LM Start	2.04	Rating **	M	Issue No.	7
LM End	2.14	Issue Type +	En	Location *	LS
Category	Earthen Levee			GPS Latitude/Longitude	
				Start	End
Item	Encroachments			38.794259 °	38.792907 °
				-121.695697 °	-121.696033 °
DWR ID	DWR_NA0022_01_s _ 2016_7				
Comment Code					
DT : Ditch					
Inspector Comment					
Ditch is at the toe of the levee.

View of the ditch at the levee toe on the landward side looking downstream. Spring 2016.

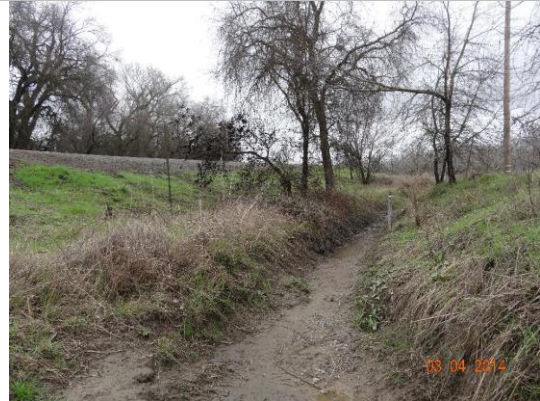
Photo 2 of 2 : UCIP\_SP\_2016\_31915\_58269.jpg

Item	DWR UCIP Field Study			38.794035 °	38.794035 °	
				-121.695870 °	-121.695870 °	
DWR ID						
Comment Code						
Inspector Comment						
FS_ID:31915 DS_ID:19538 EP_NO: N/A Repair Type: Non-Urgent Crossing Status: Indicator Found UCIP Comments: Buried gate valve on landward slope. Crossing appears to be non-functional. Landward pipe section across canal has deteriorated. Will need to contact owner to determine status of crossing. If crossing is not in use owner will need to contact the CVFPB to abandon properly according to Title 23. FIELD_STRUCT_DESC: 20-inch CM drain pipe through the levee. 20-inch gate valve on landside slope. (USACE-1953). This entry matches the Drainage or Irrigation Structure referenced in O&M manual (Station 208+15). FS Date: 3/4/2014

View of canal runs parallel on landward toe.

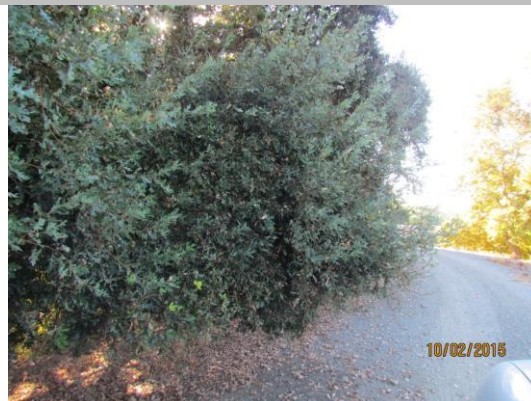
Photo 1 of 1 : SP\_2016\_NA0022\_350\_91\_20160304\_00064.jpg

LM Start	2.14	Rating **	M	Issue No.	91
LM End	2.16	Issue Type +	Ma	Location *	WS
Category	Earthen Levee			GPS Latitude/Longitude	
				Start	End
Item	Trim / Thin Trees			38.792942 °	38.792670 °
				-121.696033 °	-121.695798 °
DWR ID	DWR_NA0022_01_f_2015_91				
Comment Code					
T1 : Trim trees to at least five feet above ground level.					
Inspector Comment

View of the trees on the waterward side of the levee looking downstream. Fall 2015.

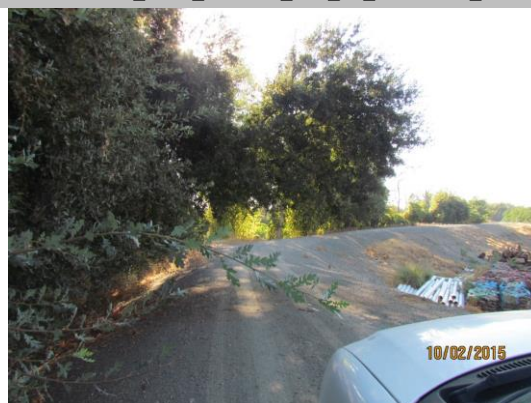
Photo 1 of 1 : SP\_2016\_NA0022\_350\_25\_20160304\_00023.jpg

LM Start	2.17	Rating **	M	Issue No.	25
LM End	2.17	Issue Type +	Ma	Location *	CR
Category	Earthen Levee			GPS Latitude/Longitude	
				Start	End
Item	Trim / Thin Trees			38.792652 °	38.792652 °
				-121.695742 °	-121.695742 °
DWR ID	DWR_NA0022_01_s_2014_25				
Comment Code					
T4 : Trim trees over roadway to at least 12 feet above ground level.					
Inspector Comment

View of the tree branch above the crown of the levee looking downstream. Fall 2015.

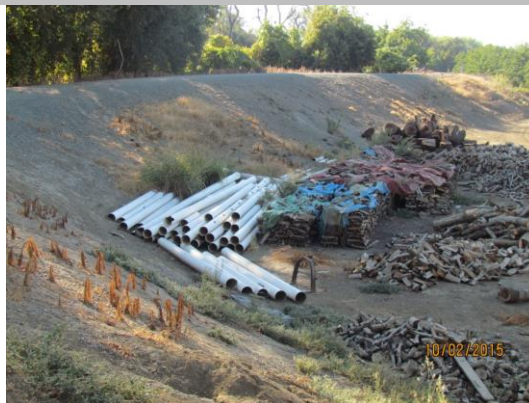
Photo 1 of 1 : SP\_2016\_NA0022\_350\_40\_20160304\_00036.jpg

LM Start	2.18	Rating **	M	Issue No.	40
LM End	2.18	Issue Type +	En	Location *	LS
Category	Earthen Levee			GPS Latitude/Longitude	
				Start	End
Item	Encroachments			38.792499 °	38.792499 °
				-121.695508 °	-121.695508 °
DWR ID	DWR_NA0022_01_s_2012_40				
Comment Code					
EQ : Equipment					
Inspector Comment					
Equipment is placed at the toe of the levee.

View of equipment on the landward side of the levee looking downstream. Fall 2015.

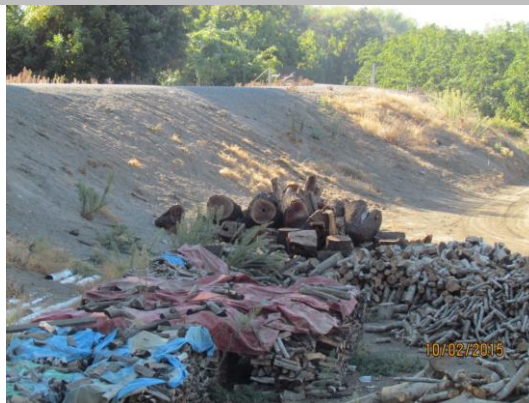
Photo 1 of 1 : SP\_2016\_NA0022\_350\_39\_20160304\_00035.jpg

LM Start	2.20	Rating **	M	Issue No.	39
LM End	2.20	Issue Type +	En	Location *	LS
Category	Earthen Levee			GPS Latitude/Longitude	
				Start	End
Item	Encroachments			38.792283 °	38.792283 °
				-121.695447 °	-121.695447 °
DWR ID	DWR_NA0022_01_s_2012_39				
Comment Code					
FW : Firewood					
Inspector Comment					
Firewood is placed at the levee toe.

View of the growing firewood at the toe of the landward side of the levee looking downstream. Fall 2015.

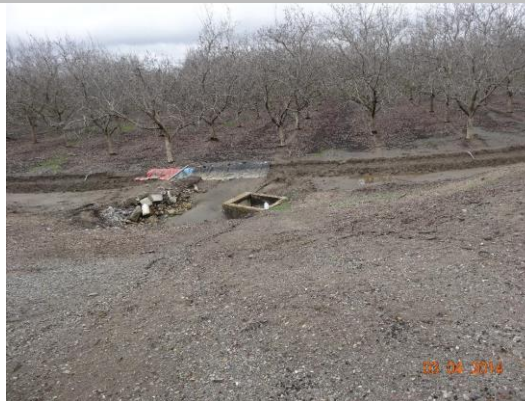
Photo 1 of 2 : UCIP\_SP\_2016\_31634\_57915.jpg

FS\_ID:31634  
DS\_ID:19525  
EP\_NO: N/A  
Repair Type: Urgent  
Crossing Status: Indicator Found  
UCIP Comments: Surface erosion near concrete box on landward side. Unable to determine if crossing is leaking or if pump is pulling sand from waterward side. Need to contact owner to determine status of crossing and to check integrity of crossing.  
FIELD\_STRUCT\_DESC: 16-inch steel drain pipe through the levee, 4-feet below the crown. Concrete well and pumphouse on waterward side. Screw gate in pumphouse. Slant pump mounted on steel structure on the waterward bank, installed under Permit No. 5951 (1967). Concrete discharge box (4x4-foot) at toe of landward slope. Overhead powerline and anchor crosses levee. Pole on both shoulders. (USACE-1953). This entry matches the Drainage or Irrigation Structure referenced in O&M manual (Station 192+60).  
FS Date: 3/4/2014

LM Start	2.35	Rating **	U	Issue No.	414 (cont)
LM End	2.35	Issue Type +	En	Location *	WS

View of landward toe.

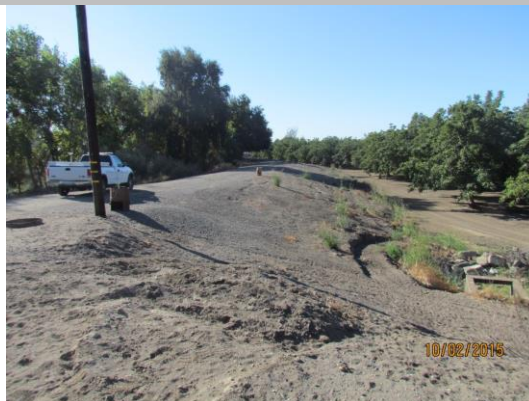
Photo 1 of 3 : SP\_2016\_NA0022\_350\_96\_20160304\_00070.jpg

LM Start	2.35	Rating **	M	Issue No.	96 (cont)
LM End	2.35	Issue Type +	Ma	Location *	LS

Perspective view of the erosion around the pipe on the landward side of the levee looking downstream. Fall 2015.

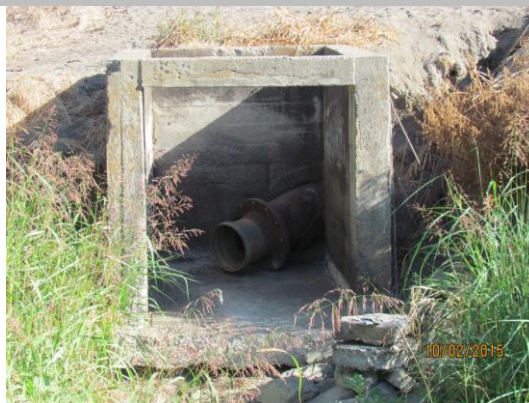
Photo 2 of 3 : SP\_2016\_NA0022\_350\_96\_20160304\_00071.jpg

View of the pipe in the concrete box. Fall 2015.

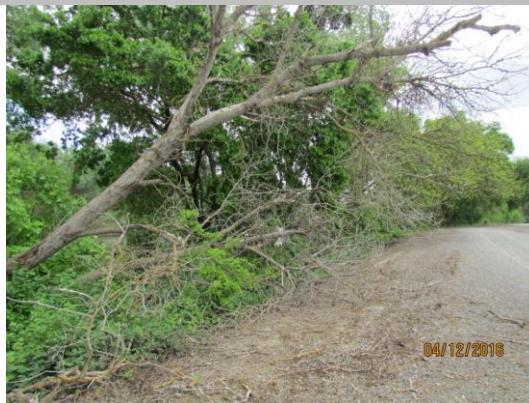
Photo 1 of 1 : SP\_2016\_NA0022\_350\_122\_20160413\_00160.jpg

LM Start	2.44	Rating **	M	Issue No.	122
LM End	2.44	Issue Type +	Ma	Location *	WS
Category	Earthen Levee			GPS Latitude/Longitude	
				Start	End
Item	Encroachments			38.788962 °	38.788962 °
				-121.694427 °	-121.694427 °
DWR ID	DWR_NA0022_01_s _ 2016_122				
Comment Code					
TR : Tree or limb					
Inspector Comment					
Fallen tree on the waterward side of the levee.

View of the tree limbs on the waterward side of the levee looking downstream. Spring 2016.

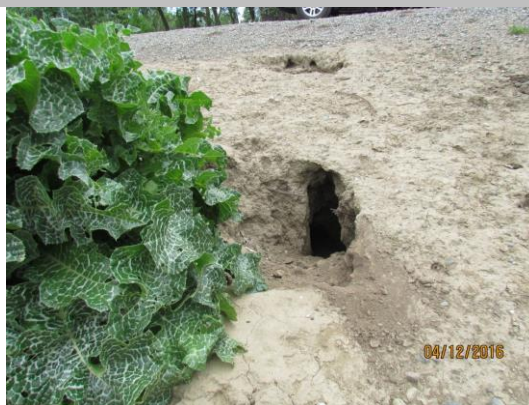
Photo 1 of 2 : SP\_2016\_NA0022\_350\_123\_20160413\_00161.jpg

LM Start	2.52	Rating **	U	Issue No.	123
LM End	2.52	Issue Type +	Ma	Location *	LS
Category	Earthen Levee			GPS Latitude/Longitude	
				Start	End
Item	Animal Control			38.787768 °	38.787768 °
				-121.694295 °	-121.694295 °
DWR ID	DWR_NA0022_01_s _ 2016_123				
Comment Code					
A3 : No rodents visible, but rodent burrows visible; need to backfill and compact or grout burrows.					
Inspector Comment

View of the rodent hole next to a tree stump on the landward side of the levee. Spring 2016.

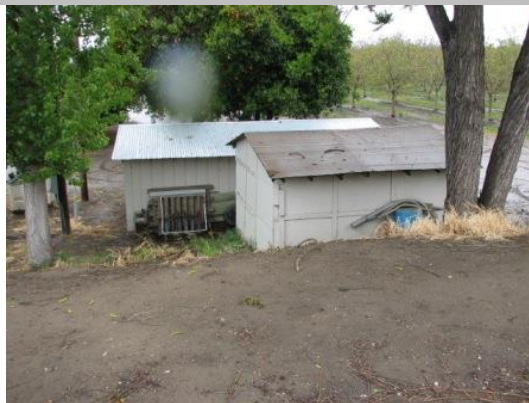
Photo 1 of 1 : SP\_2016\_NA0022\_350\_11\_20160304\_00011.jpg

LM Start	2.58	Rating **	A/W	Issue No.	11
LM End	2.58	Issue Type +	En	Location *	LS
Category	Earthen Levee			GPS Latitude/Longitude	
				Start	End
Item	Encroachments			38.787012 °	38.787012 °
				-121.694262 °	-121.694262 °
DWR ID	DWR_NA0022_01_s _ 2012_11				
Comment Code					
BU : Building					
Inspector Comment

Garage at toe.

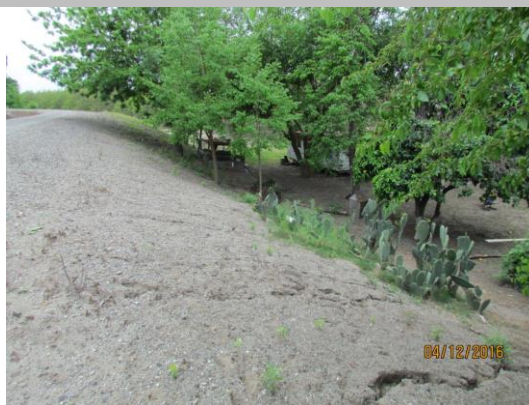
Photo 1 of 1 : SP\_2016\_NA0022\_350\_124\_20160413\_00163.jpg

LM Start	2.59	Rating **	M	Issue No.	124
LM End	2.59	Issue Type +	En	Location *	LS
Category	Earthen Levee			GPS Latitude/Longitude	
				Start	End
Item	Vegetation			38.786780 °	38.786780 °
				-121.694317 °	-121.694317 °
DWR ID	DWR_NA0022_01_s _ 2016_124				
Comment Code					
V6 : Landscaping					
Inspector Comment

View of the cactuses and trees at the toe of the levee on the landward side looking downstream. Spring 2016.

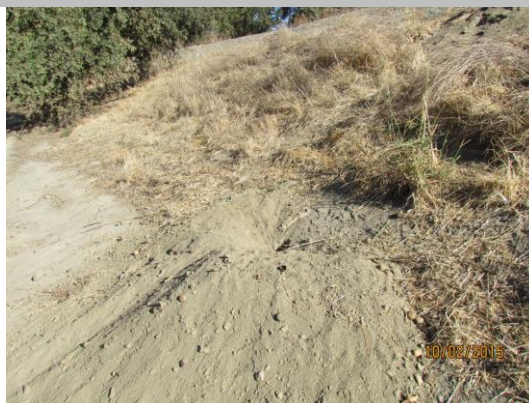
Photo 1 of 2 : SP\_2016\_NA0022\_350\_52\_20160304\_00044.jpg

LM Start	2.87	Rating **	U	Issue No.	52
LM End	2.92	Issue Type +	Ma	Location *	LS
Category	Earthen Levee			GPS Latitude/Longitude	
				Start	End
Item	Animal Control			38.783571 °	38.783021 °
				-121.692110 °	-121.691633 °
DWR ID	DWR_NA0022_01_f_2013_52				
Comment Code					
A1 : Exterminate rodents and backfill and compact or grout burrows.					
Inspector Comment

View of the rodent hole and material on the landward side of the levee.  
Fall 2015.

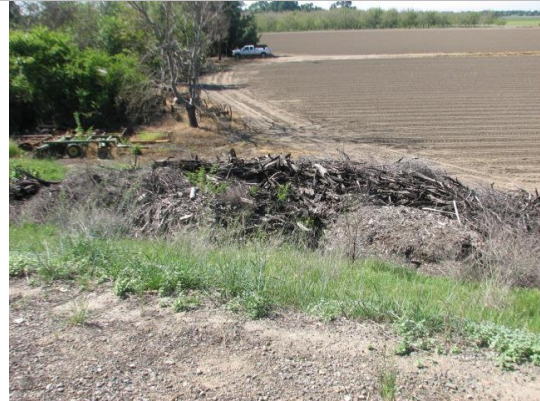
Photo 1 of 1 : SP\_2016\_NA0022\_350\_42\_20160304\_00037.jpg

LM Start	3.02	Rating **	M	Issue No.	42
LM End	3.02	Issue Type +	En	Location *	LS
Category	Earthen Levee			GPS Latitude/Longitude	
				Start	End
Item	Encroachments			38.782239 °	38.782239 °
				-121.690037 °	-121.690037 °
DWR ID	DWR_NA0022_01_s _ 2014_42				
Comment Code					
PR : Prunings					
Inspector Comment

A large pruning pile near the toe of the levee. Spring 2014

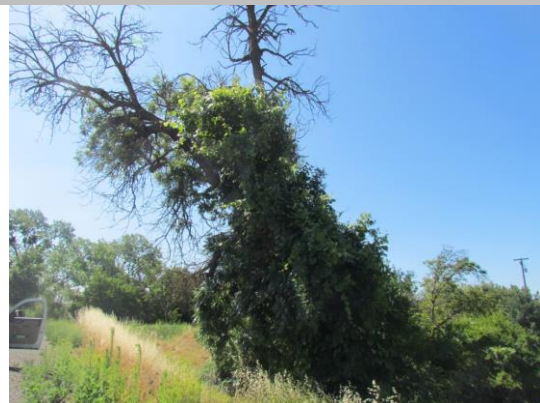
Photo 1 of 1 : SP\_2016\_NA0022\_350\_77\_20160304\_00054.jpg

LM Start	3.03	Rating **	A/W	Issue No.	77
LM End	3.03	Issue Type +	Ma	Location *	LS
Category	Earthen Levee			GPS Latitude/Longitude	
				Start	End
Item	Encroachments			38.782142 °	38.782142 °
				-121.689760 °	-121.689760 °
DWR ID	DWR_NA0022_01_s _ 2015_77				
Comment Code					
TR : Tree or limb					
Inspector Comment					
The tree looks like it's dying and needs to be monitored.

View of the dying tree on the landward side of the levee looking downstream. Spring 2015.

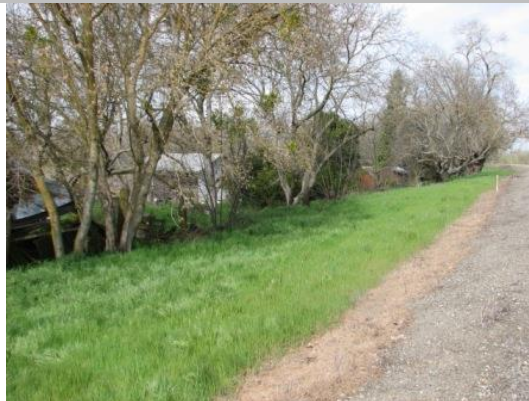
Photo 2 of 2 : SP\_2016\_NA0022\_350\_12\_20160304\_00013.jpg

LM Start	3.06	Rating **	A/W	Issue No.	12 (cont)	
LM End	3.14	Issue Type +	En	Location *	LS	
Category	Earthen Levee			GPS Latitude/Longitude		
				Start		End
Item	Encroachments			38.781828 °	38.780852 °	
				-121.689415 °	-121.688887 °	
DWR ID	DWR_NA0022_01_s_2012_12					
Comment Code						
BU : Building						
Inspector Comment

The buildings are encroaching into the levee slope.

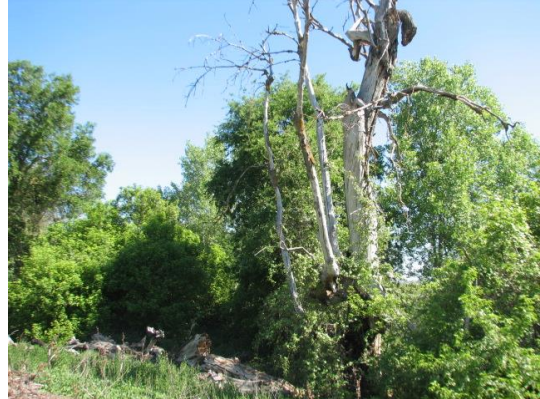
Photo 1 of 2 : SP\_2016\_NA0022\_350\_47\_20160304\_00042.jpg

LM Start	<b>3.14</b>	Rating **	M	Issue No.	<b>47 (cont)</b>
LM End	<b>3.14</b>	Issue Type +	En	Location *	WS

Some trees have fallen and others are dying and need to be monitored.  
The trees may pose a threat to the levee. Spring 2014

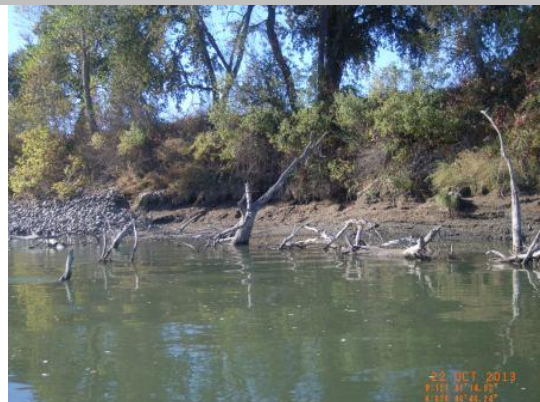
Photo 1 of 1 : SP\_2016\_NA0022\_350\_5\_20160304\_00006.jpg

LM Start	3.18	Rating **	M	Issue No.	5
LM End	3.28	Issue Type +	Ma	Location *	WS
Category	Supplemental			GPS Latitude/Longitude	
				Start	End
Item	2015 USACE Erosion Survey, DRAFT			38.780407 °	38.779137 °
				-121.688238 °	-121.687432 °
DWR ID	DWR_NA0022_01_s _ 2016_5				
Comment Code					
Inspector Comment					
2006 - Short section is into the levee toe, rest is near the levee toe. Mass failure and fluvial erosion of depositional material. Rock at the upstream and downstream ends. 2011 - Minor new erosion. 2012 - Slope continues to steepen, tree roots have become exposed, and new eddy formed. 2015: No observed changes. [2015 Site ID: SAC_86-9_R]

USACE 2013 Photo #1

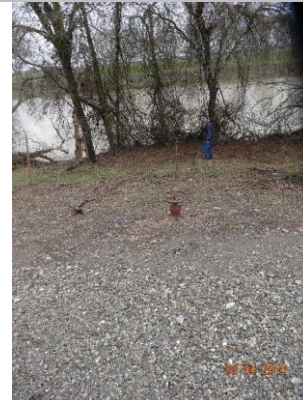
Photo 1 of 2 : UCIP\_SP\_2016\_39858\_71841.jpg

LM Start	3.23	Rating **	M	Issue No.	424
LM End	3.23	Issue Type +	En	Location *	WS
Category	Supplemental			GPS Latitude/Longitude	
				Start	End
Item	DWR UCIP Field Study			38.779625 °	38.779625 °
				-121.688090 °	-121.688090 °
DWR ID					
Comment Code					
Inspector Comment					
FS_ID:39858 DS_ID:19526 EP_NO: 3205 Repair Type: Non-Urgent Crossing Status: Found UCIP Comments: Need to contact owner to determine status of crossing. If crossing is no longer used need to coordinate with CVFPB for proper abandonment. FIELD_STRUCT_DESC: 12-inch pipe through the levee, 4-feet below the crown. Pump on the waterward band. Gate valve on the waterward slope. Siphon breaker in 18-inch concrete pipe riser on the landward slope. 36-inch concrete standpipe at toe of landward slope. Metal cutoff wall installed. (Permit No. 3205-1959) FS Date: 3/4/2014

View of waterward side.

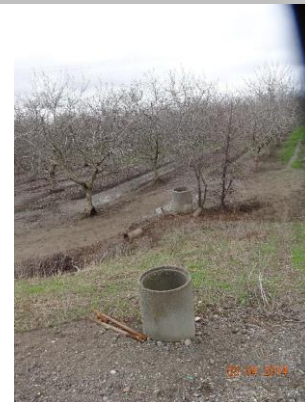
Photo 1 of 2 : UCIP\_SP\_2016\_31916\_58275.jpg

LM Start	3.24	Rating **	M	Issue No.	407
LM End	3.24	Issue Type +	En	Location *	WS
Category	Supplemental			GPS Latitude/Longitude	
				Start	End
Item	DWR UCIP Field Study			38.779543 °	38.779543 °
				-121.688170 °	-121.688170 °
DWR ID					
Comment Code					
Inspector Comment					
FS_ID:31916					
DS_ID:19545					
EP_NO: N/A					
Repair Type: Non-Urgent					
Crossing Status: Indicator Found					
UCIP Comments: Need to contact owner--Crossing appears to be abandoned. If crossing is no longer in use, crossing need to be abandoned properly per Title 23.					
FIELD_STRUCT_DESC: Abandoned 12-inch steel pipe through the levee. Pump on waterward side. Concrete standpipe on landward side. (USACE-1953). This entry matches the Drainage or Irrigation Structure referenced in O&M manual (Station 144+80). Pipe was abandoned and replaced under Permit No. 3205 (1959).					
FS Date: 3/4/2014

View of landward side.

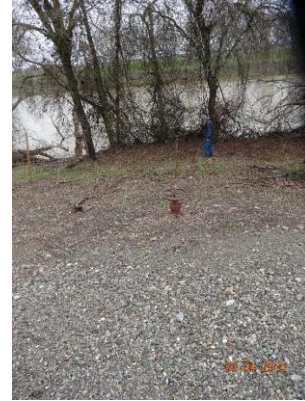
Photo 2 of 2 : UCIP\_SP\_2016\_31916\_58274.jpg

LM Start	3.24	Rating **	M	Issue No.	407 (cont)
LM End	3.24	Issue Type +	En	Location *	WS
Category	Supplemental			GPS Latitude/Longitude	
				Start	End
Item	DWR UCIP Field Study			38.779543 °	38.779543 °
				-121.688170 °	-121.688170 °
DWR ID					
Comment Code					
Inspector Comment					
FS_ID:31916 DS_ID:19545 EP_NO: N/A Repair Type: Non-Urgent Crossing Status: Indicator Found UCIP Comments: Need to contact owner--Crossing appears to be abandoned. If crossing is no longer in use, crossing need to be abandoned properly per Title 23. FIELD_STRUCT_DESC: Abandoned 12-inch steel pipe through the levee. Pump on waterward side. Concrete standpipe on landward side. (USACE-1953). This entry matches the Drainage or Irrigation Structure referenced in O&M manual (Station 144+80). Pipe was abandoned and replaced under Permit No. 3205 (1959). FS Date: 3/4/2014

View of waterward side.

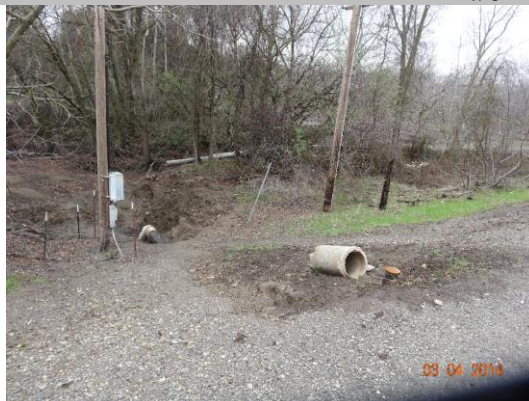
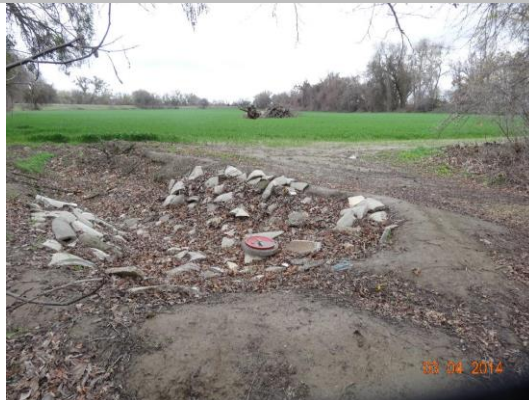
Comment Code					
Inspector Comment					
FS_ID:31917 DS_ID:19527 EP_NO: 3729 Repair Type: Non-Urgent Crossing Status: Found UCIP Comments: Crossing has been modified. Need to contact owner to determine additional information pertaining to the modifications. FIELD_STRUCT_DESC: 10-inch drain pipe through the levee, 3.0 feet below the crown. 1.5-inch conduit through the levee. 1-foot below the crown. Service pole and meter at toe of landward slope. Gate valve and pump on the waterward bank. Access ramp to pump location. Siphon breaker on the landward shoulder, in 12-inch concrete riser. Metal cutoff wall installed. (Permit No. 3729-1961). FS Date: 3/4/2014

LM Start	<b>3.41</b>	Rating **	M	Issue No.	<b>408 (cont)</b>
LM End	<b>3.41</b>	Issue Type +	En	Location *	WS

View of landward side, photo 1 of 2.

View of landward side, photo 2 of 2.

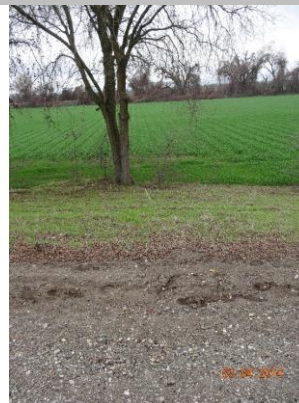
Photo 1 of 2 : UCIP\_SP\_2016\_38996\_69568.jpg

Comment Code					
Inspector Comment					
FS_ID:38996 DS_ID:19528 EP_NO: 3722 Repair Type: Non-Urgent Crossing Status: Found UCIP Comments: Pipe visible only on waterward side--Pipe needs to be properly abandoned per Title 23. Need to contact owner to determine status of crossing. FIELD_STRUCT_DESC: Abandoned 10-inch steel drain pipe through the levee, 3.0 feet below the crown. 1-1/2 inch conduit 1 foot below the crown. Pump and gate valve on the waterward bank. Metal cutoff walls at centerline of levee. Siphon breaker on the landward shoulder in 12-inch concrete riser. Pipe connects to existing 24-inch concrete standpipe at landward toe. (Permit No. 3722-1961). No standpipe found on landward toe. FS Date: 3/4/2014

LM Start	3.55	Rating **	M	Issue No.	416 (cont)
LM End	3.55	Issue Type +	En	Location *	WS

View of landward side.

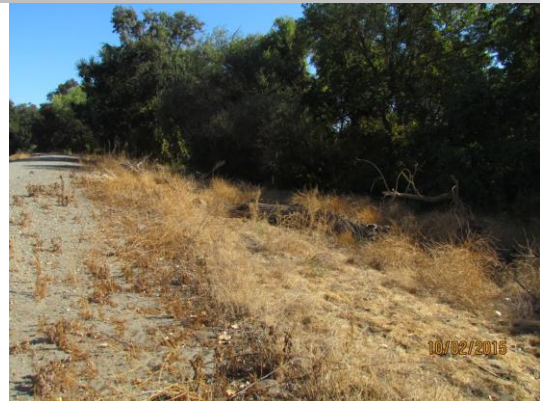
Photo 1 of 1 : SP\_2016\_NA0022\_350\_89\_20160304\_00063.jpg

LM Start	3.64	Rating **	M	Issue No.	89
LM End	3.64	Issue Type +	Ma	Location *	WS
Category	Earthen Levee			GPS Latitude/Longitude	
				Start	End
Item	Encroachments			38.774041 °	38.774041 °
				-121.687686 °	-121.687686 °
DWR ID	DWR_NA0022_01_s _ 2012_89				
Comment Code					
TR : Tree or limb					
Inspector Comment

View of the fallen tree on the waterward side of the levee looking upstream. Fall 2015.

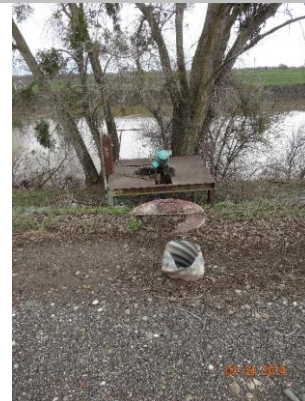
Comment Code					
Inspector Comment					
FS_ID:38999 DS_ID:19529 EP_NO: 4570 Repair Type: Non-Urgent Crossing Status: Found UCIP Comments: Need to contact owner to determine status of crossing. CMP riser damage on waterward slope. FIELD_STRUCT_DESC: 16-inch drain pipe through the levee, 5.0 feet below the crown. Metal plate welded on the waterward end. Pump, 1-1/2-inch conduit, and gate valve in concrete U-headwall on waterward bank, installed under Permit 7618A (1971). Pipe extends from pump to concrete standpipe on the landward side, pipe exposed on the landward slope. Water meter in 36-inch CM pipe riser on the waterward slope. Siphon breaker on the landward shoulder, in 7-inch metal riser. 30-inch concrete riser at toe of landward slope. Metal cutoff wall installed. (Permit No. 4570-1964). FS Date: 3/4/2014

LM Start	<b>4.01</b>	Rating **	M	Issue No.	<b>417 (cont)</b>
LM End	<b>4.01</b>	Issue Type +	En	Location *	LS

View of landward side.

View of waterward side.

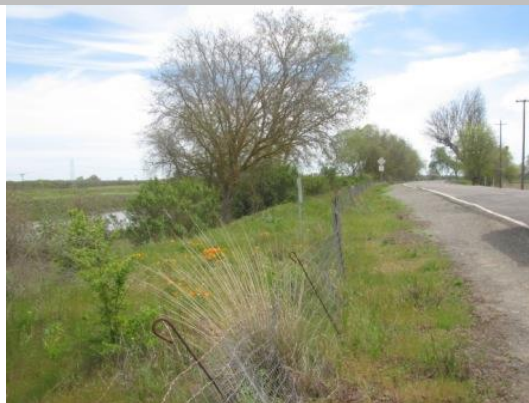
Photo 1 of 2 : SP\_2016\_NA0022\_350\_36\_20160304\_00032.jpg

LM Start	4.25	Rating **	A/W	Issue No.	36
LM End	4.49	Issue Type +	Ma	Location *	WS
Category	Earthen Levee			GPS Latitude/Longitude	
				Start	End
Item	Vegetation			38.767125 °	38.764582 °
				-121.693267 °	-121.690285 °
DWR ID	DWR_NA0022_01_s _ 2012_36				
Comment Code					
V8 : Environmental Requirements.					
Inspector Comment

Another view of the site.

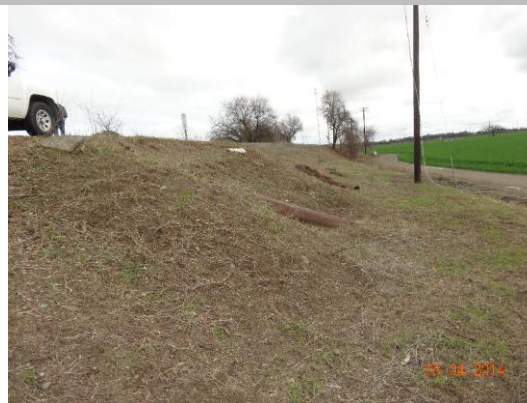
Photo 1 of 2 : UCIP\_SP\_2016\_31986\_58442.jpg

LM Start	4.44	Rating **	M	Issue No.	411
LM End	4.44	Issue Type +	En	Location *	LS
Category	Supplemental			GPS Latitude/Longitude	
				Start	End
Item	DWR UCIP Field Study			38.765142 °	38.765142 °
				-121.690963 °	-121.690963 °
DWR ID					
Comment Code					
Inspector Comment					
FS_ID:31986					
DS_ID:19530					
EP_NO: 9409					
Repair Type: Non-Urgent					
Crossing Status: Found					
UCIP Comments: Pump station not found. Crossing appears to be abandon. Need to contact owner to determine status. Repair site on waterward side--waterward slope revegetated.					
FIELD_STRUCT_DESC: 16-inch steel pipe through the levee, 6.4 feet below the crown. Pump and control valve on the waterward bank. Ramp on landward slope. (ABO Permit No. 9409-1974).					
FS Date: 3/4/2014

View of landward side.

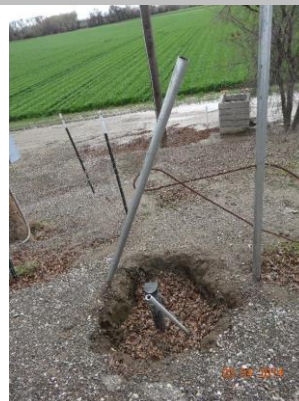
Photo 1 of 2 : UCIP\_SP\_2016\_42864\_69573.jpg

Comment Code					
Inspector Comment					
FS_ID:42864 DS_ID:19537 EP_NO: 18298 Repair Type: Urgent Crossing Status: Found UCIP Comments: Subsidence visible where siphon breaker is located on landward side. Unable to determine if subsidence is due to poor compaction or leak at siphon breaker. Need to contact owner to address issue. FIELD_STRUCT_DESC: 14-inch steel water pipe through the levee, 2-feet below the levee crown. Supported by 6 pilings on waterside slope, extending into channel. Pump platform supported by steel structure on waterward side. Siphon breaker and air release valve on the landward shoulder. Concrete distribution box at landward toe. Rock riprap on the waterward slope. (Permit No. 18298-2007) FS Date: 3/4/2014

LM Start	<b>4.52</b>	Rating **	U	Issue No.	<b>422 (cont)</b>
LM End	<b>4.52</b>	Issue Type +	En	Location *	WS

View of landward side--subsidence near levee crown.

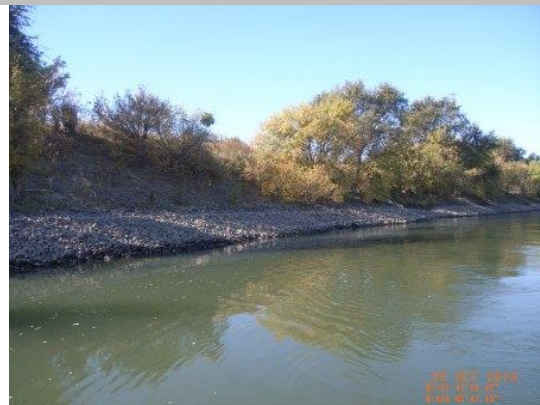
Photo 1 of 1 : SP\_2016\_NA0022\_350\_3\_20160304\_00002.jpg

LM Start	4.66	Rating **	M	Issue No.	3
LM End	4.86	Issue Type +	Ma	Location *	WS
Category	Supplemental			GPS Latitude/Longitude	
				Start	End
Item	2015 USACE Erosion Survey, DRAFT			38.763486 °	38.763313 °
				-121.687567 °	-121.684038 °
DWR ID	DWR_NA0022_01_s _ 2016_3				
Comment Code					
Inspector Comment					
2009 - Erosion into the levee toe. Some cobbles have been dumped into the erosion pockets. 2010 - Old cobble site starting to unravel. 2012 - Slope continues to steepen and new animal holes. 2013 - Downstream cobble is unraveling. 2015: No observed changes. [2015 Site ID: SAC_85-4_R]

USACE 2013 Photo #1

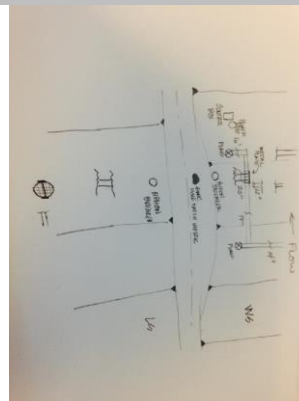
Photo 1 of 2 : UCIP\_SP\_2016\_42865\_58451.jpg

LM Start	4.69	Rating **	U	Issue No.	423
LM End	4.69	Issue Type +	En	Location *	WS
Category	Supplemental			GPS Latitude/Longitude	
				Start	End
Item	DWR UCIP Field Study			38.763087 °	38.763087 °
				-121.687125 °	-121.687125 °
DWR ID					
Comment Code					
Inspector Comment					
FS_ID:42865 DS_ID:19531 EP_NO: N/A Repair Type: Urgent Crossing Status: Found UCIP Comments: Signs of sink hole repair on levee crown. Owner will need to contact CVFPB to address sink hole repair. FIELD_STRUCT_DESC: 20-inch steel pipe through the levee, 4.7 feet below the crown. Two slant pumps on the waterward slope. No control valves. Ramp on landward slope. (ABO Permit No. 9408-1974). FS Date: 3/4/2014

Plan view of crossing and appurtenances at levee mile 4.77.

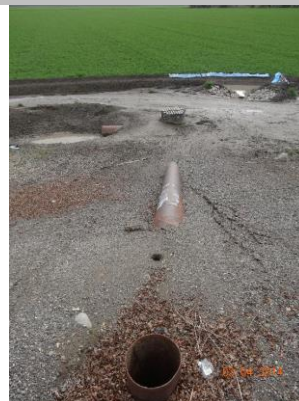
Photo 2 of 2 : UCIP\_SP\_2016\_42865\_58457.jpg

LM Start	<b>4.69</b>	Rating **	U	Issue No.	<b>423 (cont)</b>
LM End	<b>4.69</b>	Issue Type +	En	Location *	WS

View of landward side.

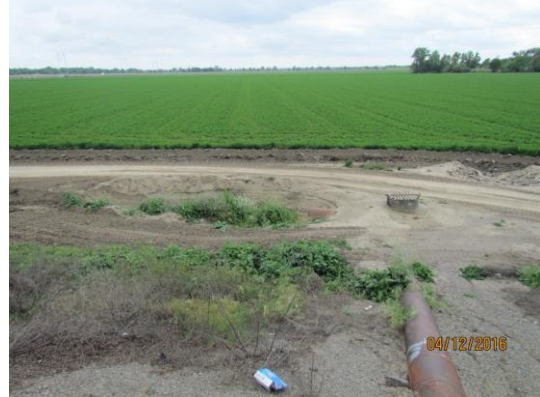
Photo 1 of 2 : SP\_2016\_NA0022\_350\_138\_20160413\_00169.jpg

LM Start	<b>4.92</b>	Rating **	M	Issue No.	<b>138 (cont)</b>
LM End	<b>4.92</b>	Issue Type +	En	Location *	LS

The start of the ditch is at the toe of the levee. Spring 2016.

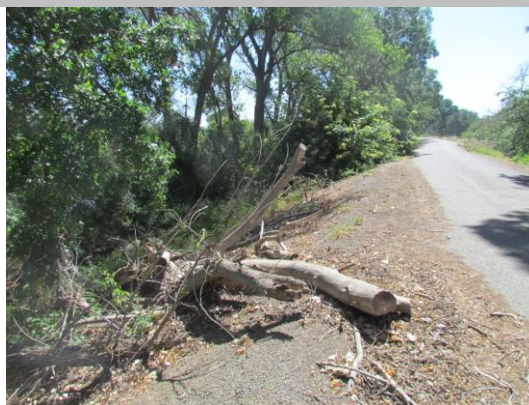
Photo 1 of 1 : SP\_2016\_NA0022\_350\_82\_20160304\_00057.jpg

LM Start	5.50	Rating **	M	Issue No.	82
LM End	5.50	Issue Type +	Ma	Location *	WS
Category	Earthen Levee			GPS Latitude/Longitude	
				Start	End
Item	Encroachments			38.759594 °	38.759594 °
				-121.673860 °	-121.673860 °
DWR ID	DWR_NA0022_01_s _ 2015_82				
Comment Code					
TR : Tree or limb					
Inspector Comment					
A tree fell over on the waterward side of the levee.

View of the fallen tree on the waterward side of the levee looking downstream. Spring 2015.
